The Road Inventory of Nisqually National Wildlife Refuge Olympia, WA

Prepared By: Federal Highway Administration Central Federal Lands Highway Division April 2013

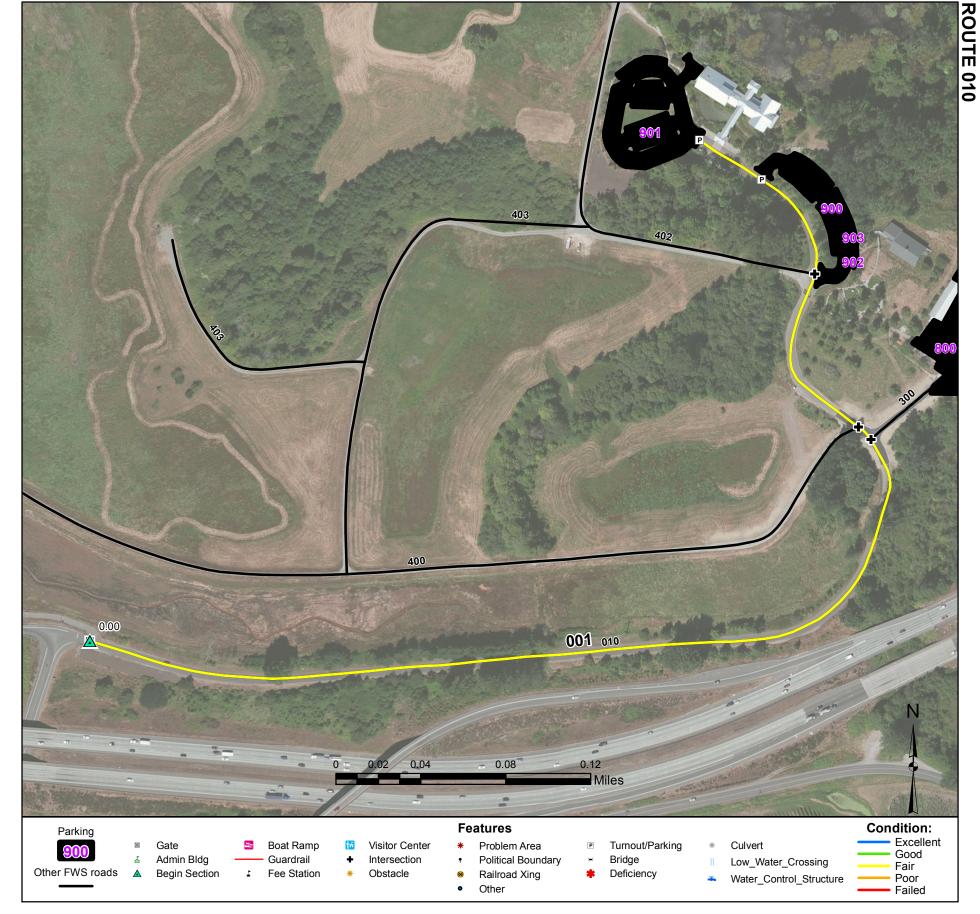
Brown Farm Road

Asset Number	10003521
Section Number	001
Section Length (miles)	0.63
Inspection Date	02-26-2013
Surface Type	Asphalt
Number of Lanes	
Roadway Width (feet)	22
Condition	Fair
Remaining Service Life (years)	10
Estimated Cost to Repair	\$78,700
Current Replacement Value	\$871,300

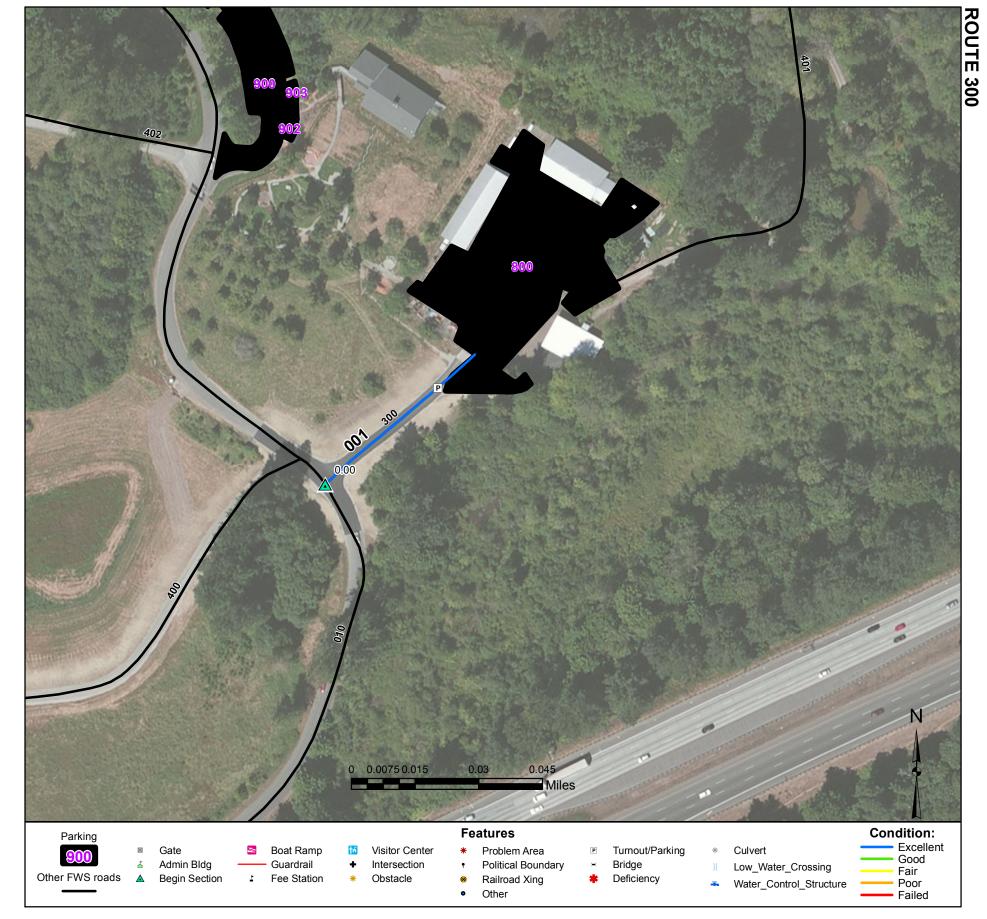
Maintenance Shop Road

Asset Number Section Number Section Length (miles)	10003486 001 0.04		
Inspection Date	02-26-2013		
Surface Type Number of Lanes Roadway Width (feet)	Asphalt 2 16		
Condition	Excellent		
Remaining Service Life (years)	20		
Estimated Cost to Repair	\$0		
Current Replacement Value	\$55,300

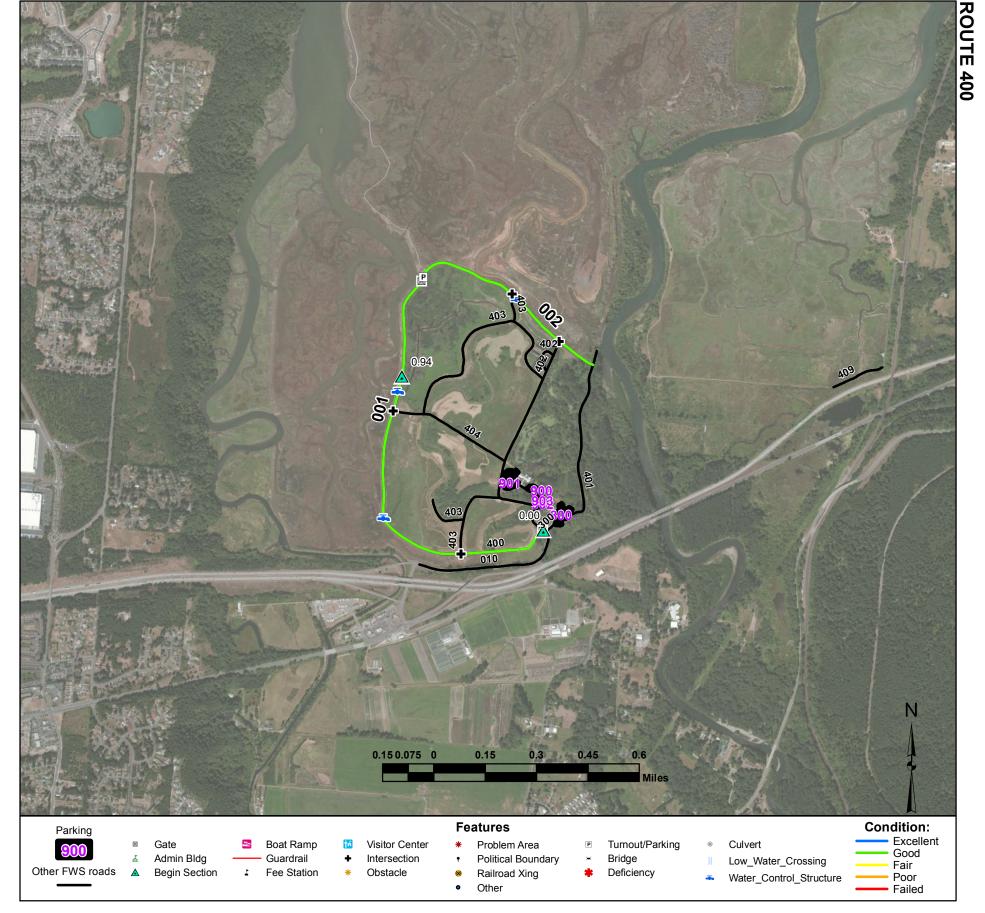
New Barn Farm Dike Road

J
Asset Number	-	-			
Section Number	001	002			
Section Length (miles)	0.94	0.92			
Inspection Date	02-26-2013	02-26-2013			
Surface Type	Gravel	Gravel			
Number of Lanes	1	1			
Roadway Width (feet)	14	14			
Condition	Good	Good			
Remaining Service Life (years)	7	5			
Estimated Cost to Repair	\$1,800	\$1,700			
Current Replacement Value	\$749,400	\$733,400			
	ı	1	1	1	1

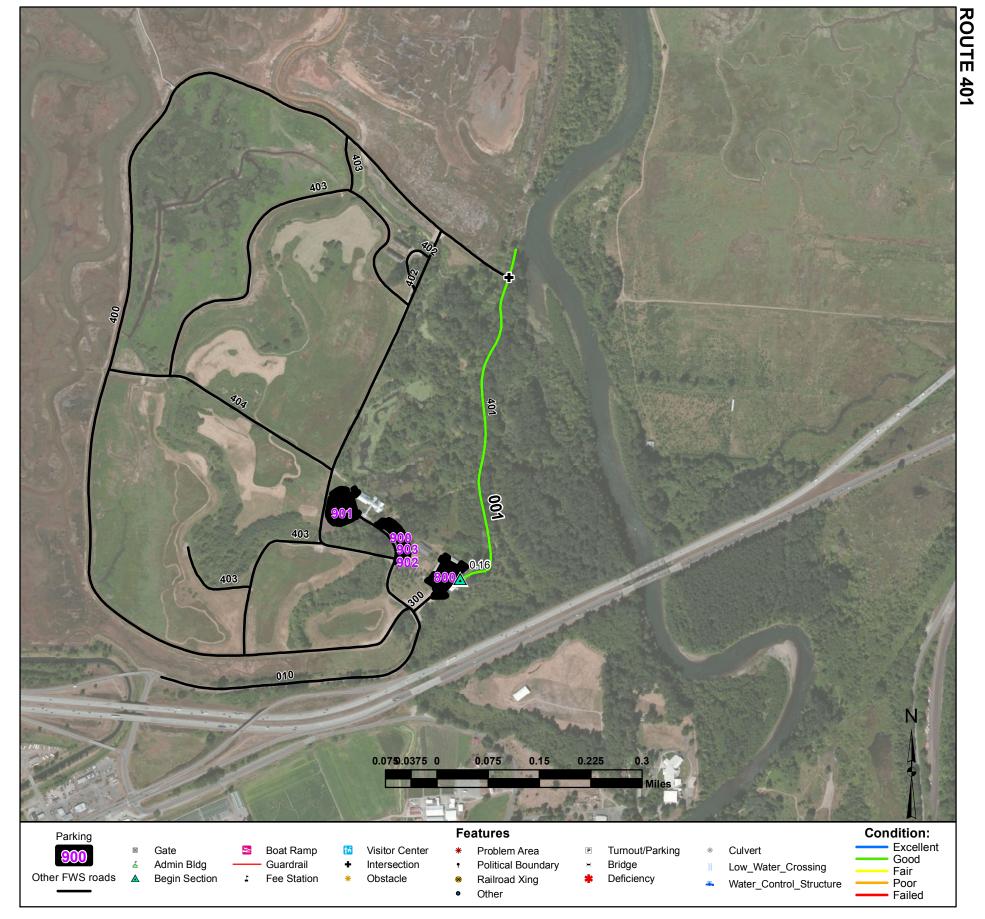
Old Barn Farm Dike Road

Asset Number	10065128		
Section Number	001		
Section Length (miles)	0.52		
Inspection Date	02-26-2013		
Surface Type	Gravel		
Number of Lanes	1		
Roadway Width (feet)	14		
Condition	Good		
Remaining Service Life (years)	5		
Estimated Cost to Repair	\$1,000		
Current Replacement Value	\$414,500

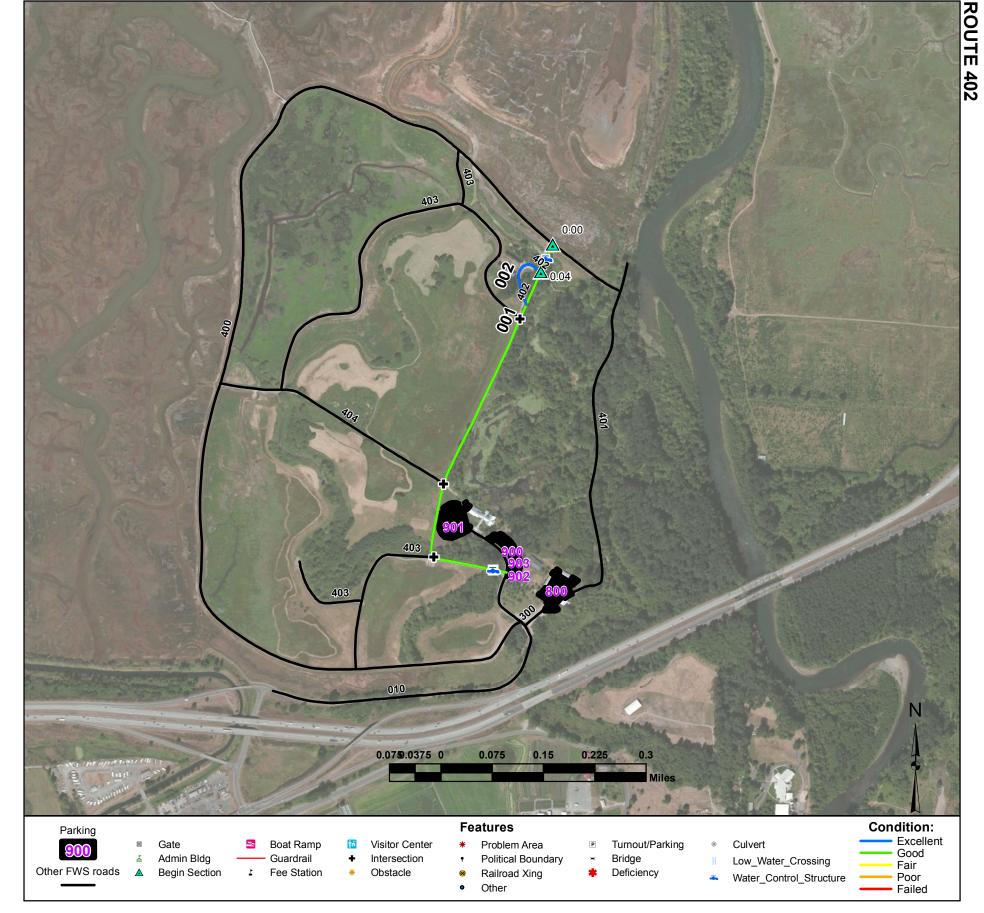
Road to Twin Barns

10003505	10003505			
001	002			
0.60	0.08			
02-26-2013	02-26-2013			
Gravel	Gravel			
1	2			
14	20			
Good	Excellent			
7	9			
\$1,100	\$0			
\$478,300	\$63,800			
	001 0.60 02-26-2013 Gravel 1 14 Good 7 \$1,100	001 002 0.60 0.08 02-26-2013 02-26-2013 Gravel Gravel 1 2 14 20 Good Excellent 7 9 \$1,100 \$0	001 002 0.60 0.08 02-26-2013 02-26-2013 Gravel 1 2 14 20 Good Excellent 7 9 \$1,100 \$0	001 002 0.60 0.08 02-26-2013 02-26-2013 02-26-2013 Gravel 1 2 14 20 Good Excellent 7 9 \$1,100 \$0

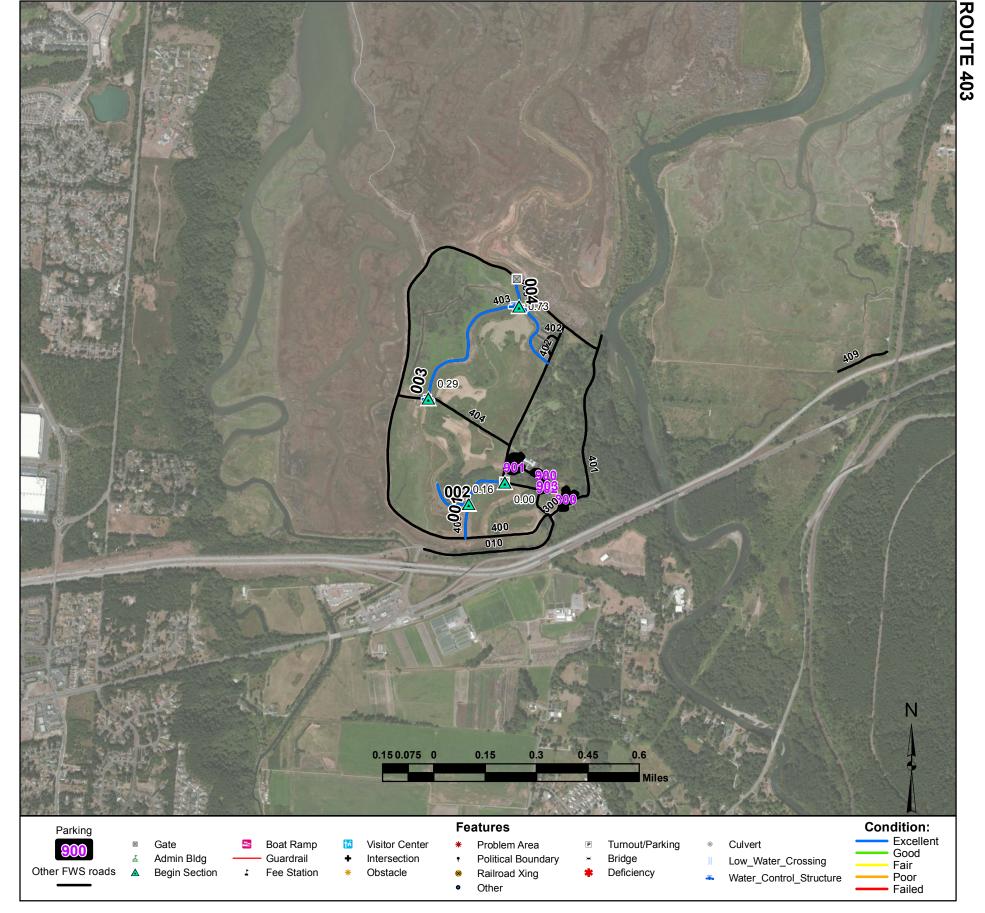
Interior Dike Road

Asset Number	10065128	10065128	10065128	10065128
Section Number	001	002	003	004
Section Length (miles)	0.25	0.13	0.66	0.07
Inspection Date	02-26-2013	02-26-2013	02-26-2013	02-26-2013
Surface Type	Gravel	Gravel	Gravel	Gravel
Number of Lanes	1	1	1	1
Roadway Width (feet)	12	12	12	12
Condition	Excellent	Excellent	Excellent	Excellent
Remaining Service Life (years)	8	8	8	10
Estimated Cost to Repair	\$0	\$0	\$0	\$0
Current Replacement Value	\$199,300	\$103,600	\$526,100	\$55,800

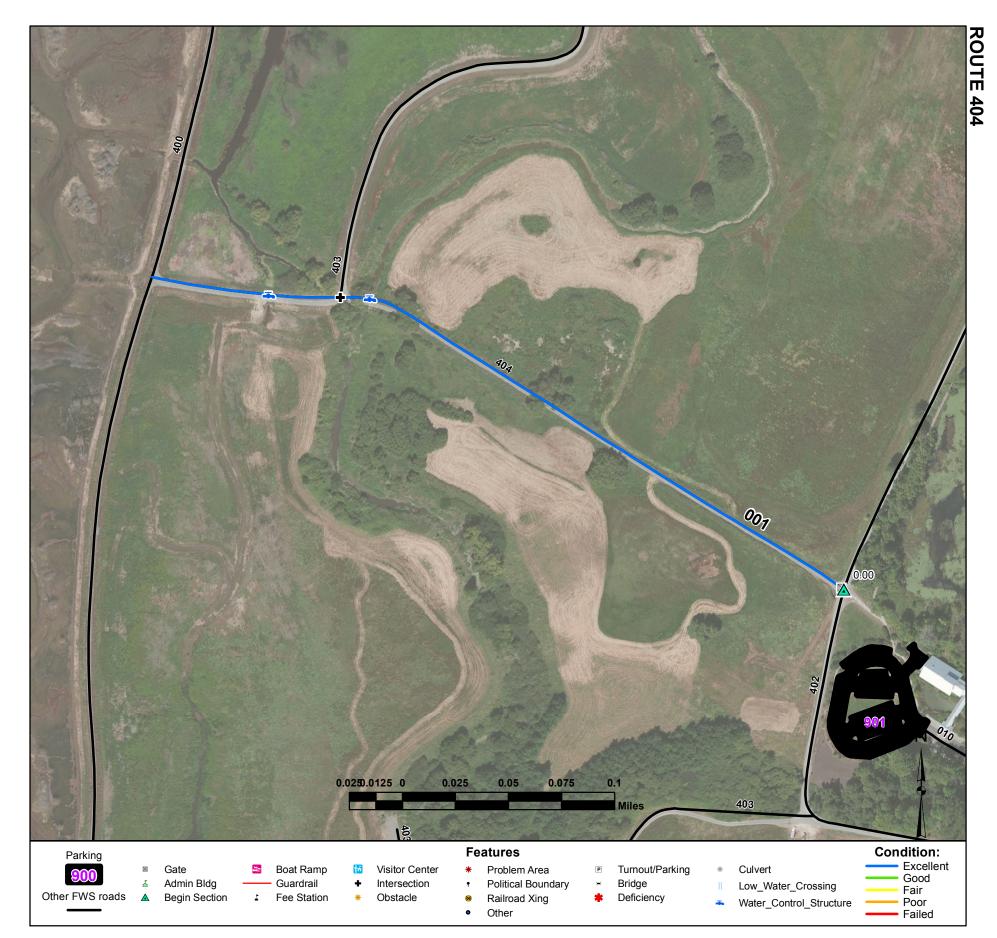
McAllister Cross Dike Road

Asset Number	10065128		
Section Number	001		
Section Length (miles)	0.36		
Inspection Date	02-26-2013		
Surface Type	Gravel		
Number of Lanes	1		
Roadway Width (feet)	12		
Condition	Excellent		
Remaining Service Life (years)	8		
Estimated Cost to Repair	\$0		
Current Replacement Value	\$287,000

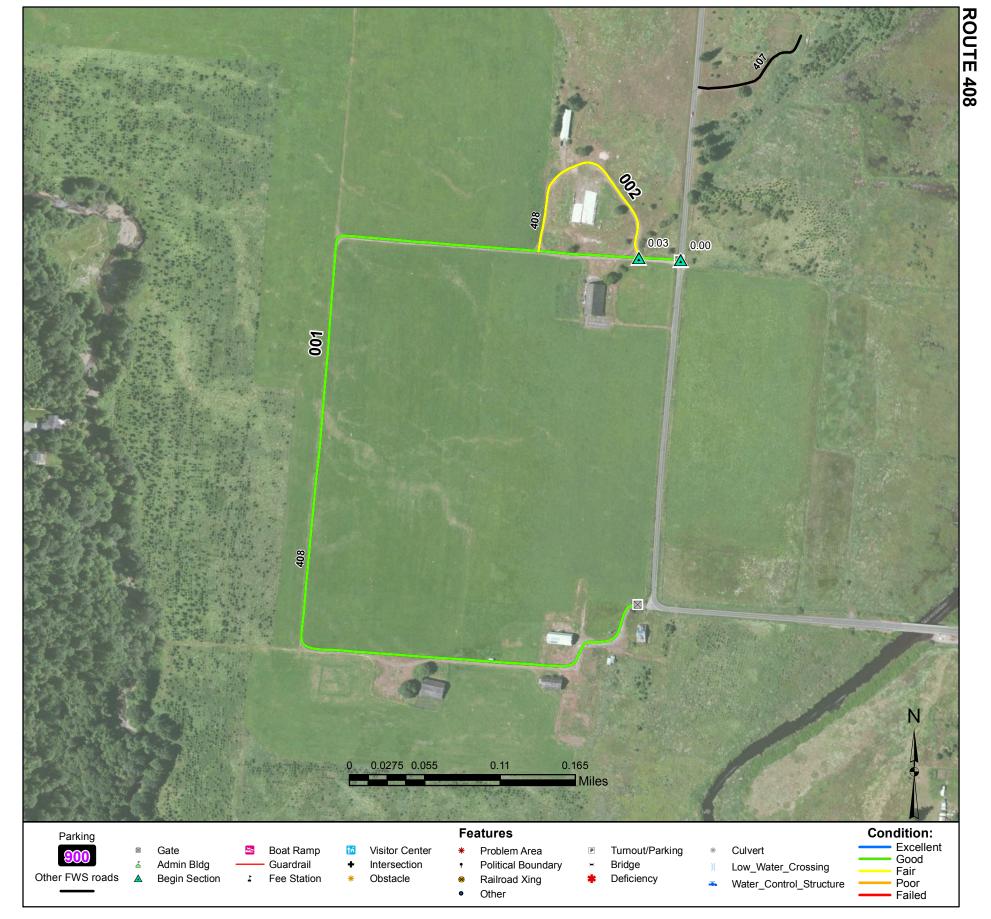
Loop Road

Asset Number	10065128	10065128		
Section Number	001	002		
Section Length (miles)	0.82	0.16		
Inspection Date	02-26-2013	02-26-2013		
Surface Type	Gravel	Gravel		
Number of Lanes	1	1		
Roadway Width (feet)	10	10		
Condition	Good	Fair		
Remaining Service Life (years)	5	4		
Estimated Cost to Repair	\$1,500	\$700		
Current Replacement Value	\$653,700	\$127,500

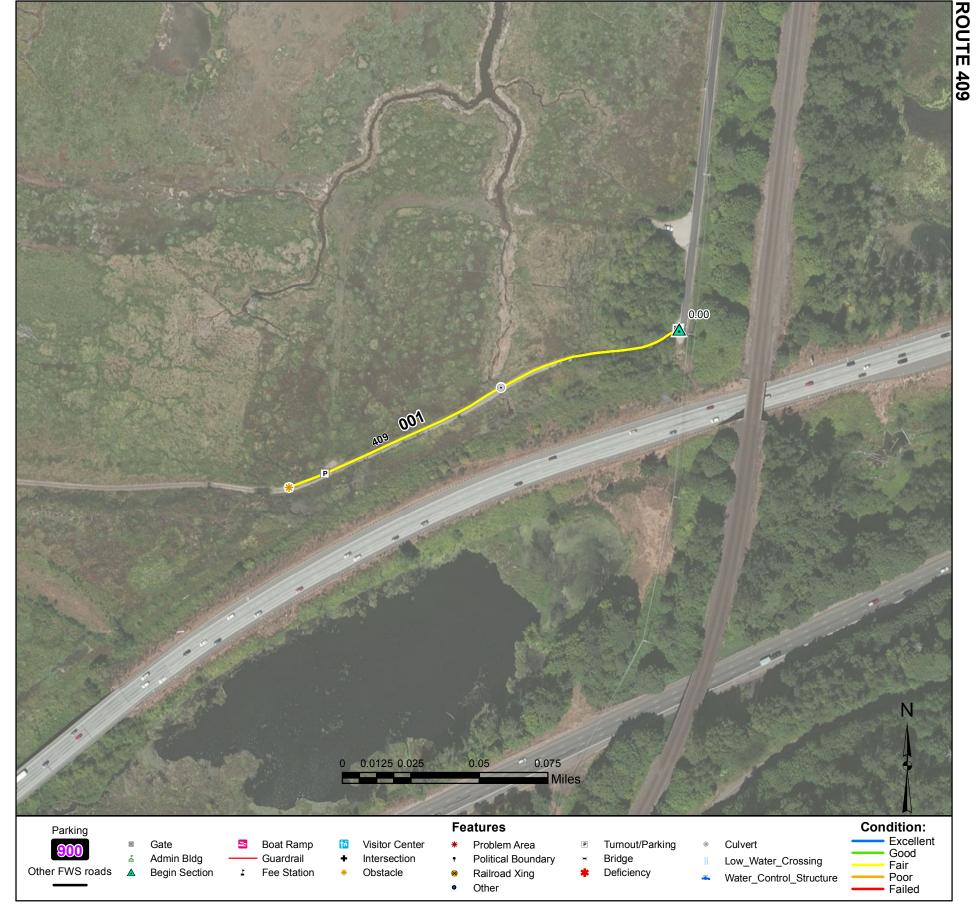
Eastside Access Road

Asset Number	10054711		
Section Number	001		
Section Length (miles)	0.15		
Inspection Date	02-26-2013		
Surface Type	Gravel		
Number of Lanes	1		
Roadway Width (feet)	12		
condition	Fair		
Remaining Service Life (years)	4		
Estimated Cost to Repair	\$600		
Current Replacement Value	\$119,600

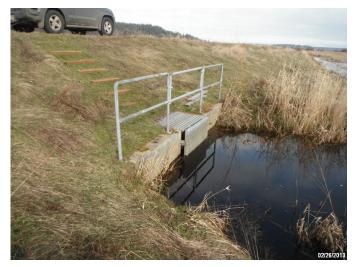
Photo: NISQ_C4_0336 Route: 400-001-0.9 Metal WCS Flashboard Riser 70ft long 36in dia. 10ft deep

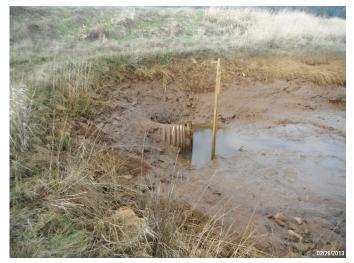
Photo: NISQ_C4_0341 Route: 400-002-1.55 Metal WCS Flashboard Riser 100ft long 36in dia. 6ft deep

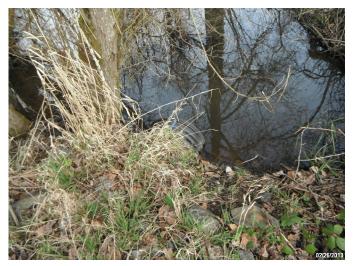
Photo: NISQ_C4_0348 Route: 402-001-0.57 Plastic WCS Flashboard Riser 45ft long 24in dia. 2ft deep 8-006

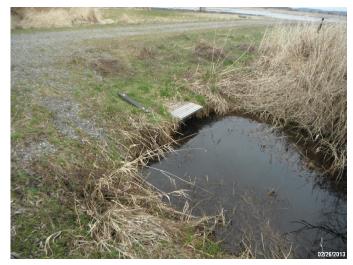
Photo: NISQ_C4_0360 Route: 403-003-0.29 Plastic WCS Flashboard Riser 40ft long 24in dia. 3ft deep

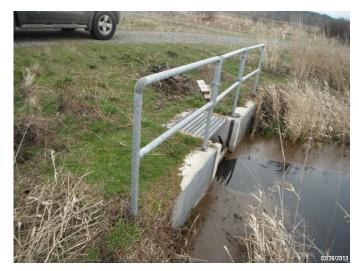
Photo: NISQ_C4_0362 Route: 403-003-0.72 Plastic WCS Flashboard Riser 45ft long 24in dia. 4ft deep

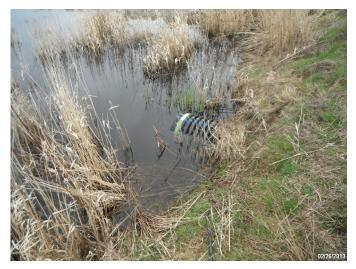
Photo: NISQ_C4_0363 Route: 403-003-0.72 Plastic WCS Flashboard Riser 45ft long 24in dia. 4ft deep

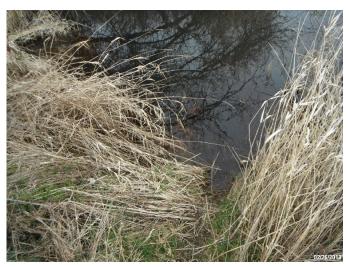
Photo: NISQ_C4_0356 Route: 404-001-0.25 Metal WCS Flashboard Riser 20ft long 24in dia. 2ft deep

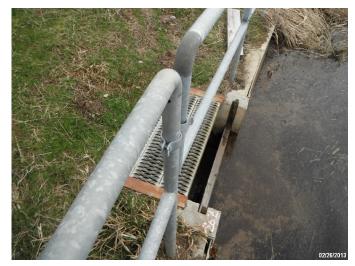
Photo: NISQ_C4_0357 Route: 404-001-0.3 Plastic WCS Flashboard Riser 40ft long 24in dia. 3ft deep

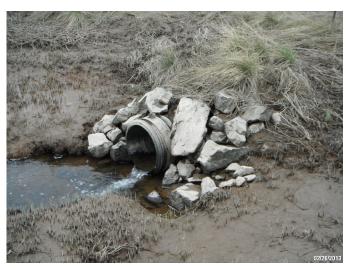
Photo: NISQ_C4_0382 Route: 409-001-0.06 Plastic Culvert 50ft long 24in dia. 3ft deep

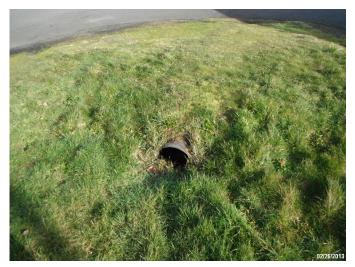
Photo: NISQ_C4_0314 Route: 901 Plastic Culvert 45ft long 12in dia. 1ft deep

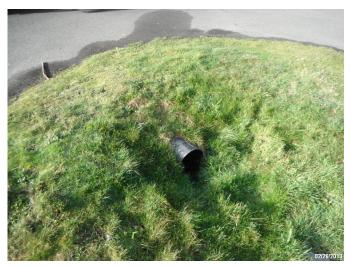
Photo: NISQ_C4_0315 Route: 901 Plastic Culvert 45ft long 12in dia. 1ft deep

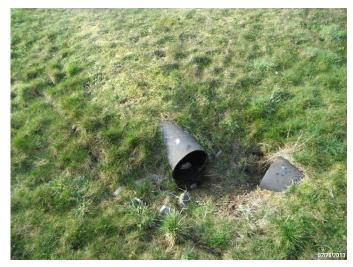
Photo: NISQ_C4_0318 Route: 901 Plastic Culvert 70ft long 12in dia. 1ft deep

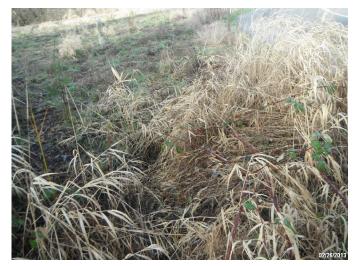
Photo: NISQ_C4_0319 Route: 901 Plastic Culvert 70ft long 12in dia. 1ft deep
